WELDING INSPECTION REPORT

Resident Engineer: Pursell, Gary **Report No:** WIR-008588 Address: 333 Burma Road Date Inspected: 30-Jul-2009

OSM Arrival Time: 1300 **Project Name:** SAS Superstructure **OSM Departure Time:** 2130 **Prime Contractor:** American Bridge/Fluor Enterprises, a JV

Bridge No: 34-0006 **Component:** Tower, Jacking and Deviation Saddles

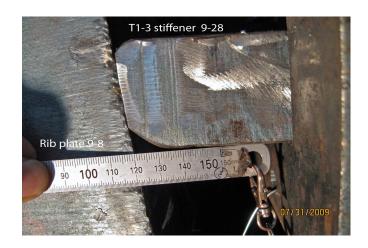
T1-3 - Stiffener plates 9ST-28, -29, -30 were in process of being fit up by JSW personnel, due to angular differences and to assist in fit up the 50mm plate, corners were chamfered, creating root openings requiring fillet leg size be increased per that established by AWS D1.5 Bridge Welding Code, ¶ 3.3.1 (for fillet welds). CWI, Mr Chung Fu Kuan was briefed on requirements to adjust fillet size and track joints to assure adjusted minimum fillet sizes are met. See attached photos for those chamfers needing the most adjustment (of the three plates identified in the opening statement). Also observed was, plate 9-9 edge, noted in WIR-007639, was getting weld build up by surfacing per BG-ECS-08-041 and associated WPS SJ-3012-6 Rev 5. Welder was K.Kobayashi 08-5023, using
